Preservation Department

CONSERVATION CONDITION REPORT AND TREATMENT PROPOSAL

Title: "US Vet Bureau – Group is beekeeping (no back stamp)" and "Rehabilitation Work – Returned soldiers assembling and studying various types of auto and truck engines."

CONSERVATION TREATMENT REPORT

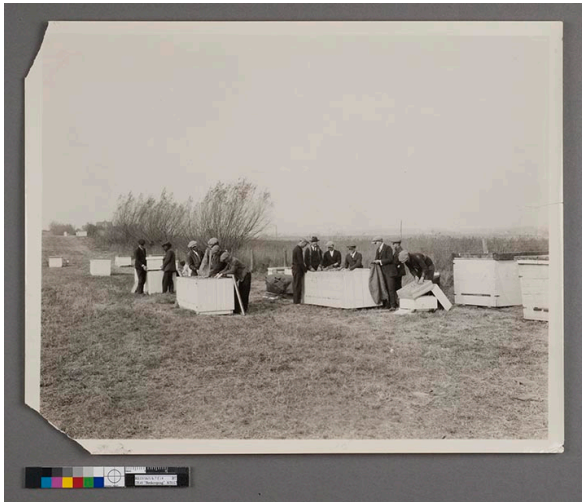
Before Treatment, recto

"Group is beekeeping": The photograph is in fair condition. There are two significant losses extending into the image area at the upper and lower left corners. There is a horizontal break 2.1 cm in length originating near the center of the right edge. There is associated damaged and loss of the carrier and image material along the break, especially near the terminus. There are several small creases, a small tear, and a small loss concentrated in the lower right corner. There is a small vertical tear at the top edge located directly to the right of the loss in the upper left corner. There is a second small vertical tear at the bottom edge, located directly to the right of the loss in the lower left corner. The surface of the emulsion shows damage from handling and previous storage, including several breaks in the emulsion measuring up to 3.7 cm in length resulting from creases seen on the verso of the support, compression/denting from the graphite inscription on the recto, a horizontal scratch near the tear in the right edge, and planar distortion and cracking from a previous paperclip at the left edge. There is some unknown brown material

on the emulsion directly to the right of the loss in the lower left corner. There is minor soiling and marks on the verso of the support.

1. Fills were made for the losses in the upper and lower left corners of "Group is beekeeping," and for the losses in the lower left corner, lower right corner, and right edge of "Auto/truck engines."

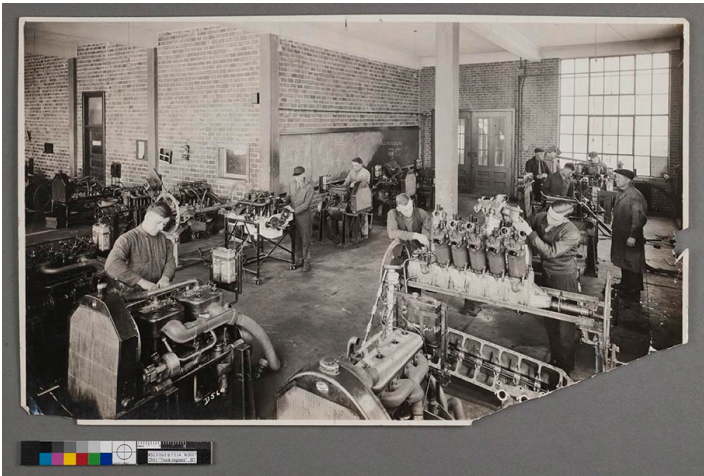
Before Treatment, recto

“Auto and truck engines:” The photograph is in fair condition. There is a significant loss extending into the image area at the lower right corner. There are two smaller losses which extend into the images area located on the right edge 4 cm above the large loss and in the lower left corner. There is a small loss at the tip of the upper right corner. There are two vertical tears approximately 1.5 cm in length originating at the tear edge of the loss in the lower right corner. The upper and lower right corners and the lower left corners show numerous breaks in the emulsion caused by creasing of the support. Several other minor breaks in the emulsion associated with creasing are seen along the edges and in the image area. There is a small puncture hole near the center of the upper edge of the support. There are two small graphite marks near the centers of the upper and lower edges of the recto. There is a small loss in the emulsion beneath the mark at the upper edge. The surface of the emulsion shows several scratches and fingerprints. There is slight silver-mirroring seen throughout, especially in high-density image areas such as the lower left corner.
