CONSERVATION CONDITION REPORT AND TREATMENT PROPOSAL

Call Number: RS 11/10/19 Barcode/Bib Record: -Title: Papers Collection: Archives Curator/Archivist: Brad Keunnan

Iowa State College Inspection Party at Allis-Chambers Club, 1909. Platinum print.

CONSERVATION TREATMENT REPORT

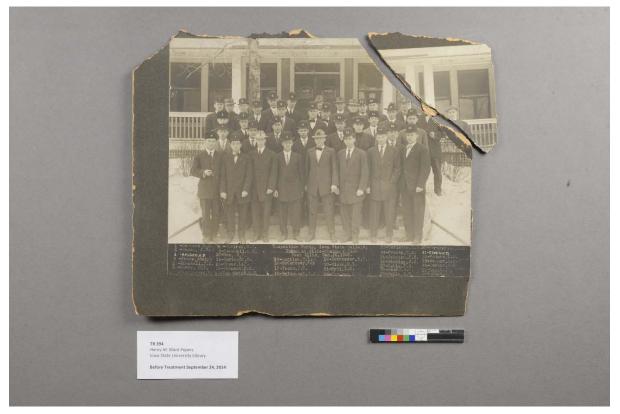
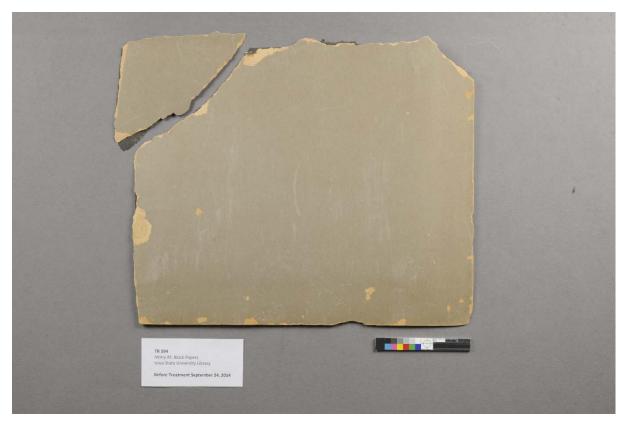
Before Treatment

The backing board is acidic and has many losses.

The top right corner of the photograph has separated.

There are many tears and cracks throughout the image.

- 1. Backing removal.
- 2. Surface cleaning.
- 3. Mending all tears, supporting creases, re-adhering separated corner.
- 4. Encapsulation.

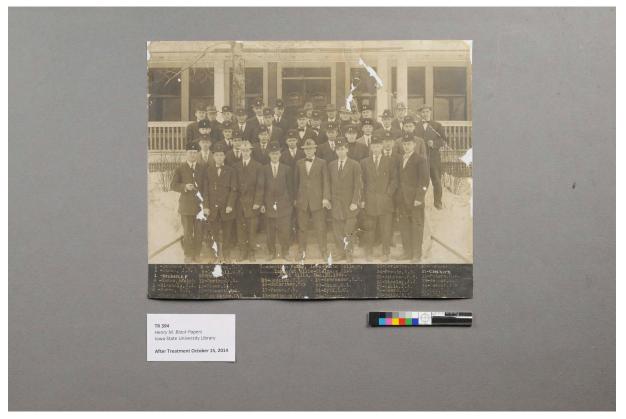
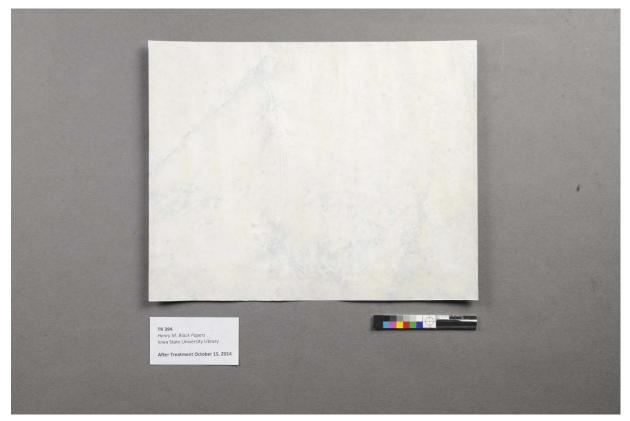
After Treatment

1. The acidic backing board was removed. Unfortunately this revealed an incredibly brittle photograph, and many areas of the photograph started to flake off, resulting in losses.

2. The photograph was surface cleaned very gently. Brushes were mainly used to wipe away debris, but in some areas, pieces of the backing board had dried to the recto of the photograph. To remove these backing board pieces, a cotton swab dampened with water was used.

3. Due to the brittle nature of the photograph, it was lined with PhotoTex tissue.

4. The losses which occurred during backing removal were then placed and adhered where they belong.

5. The object was encapsulated with Mylar, and a mat board was placed behind the photograph to add support in its encapsulation (it was not adhered).
